Overview of the 2006 Annual Surveillance and Maintenance Report (Including 4th Quarter 2006) for the DOE LM Rocky Flats Site

Rocky Flats Stewardship Council

May 7, 2007

Annual 2006 Site Surveillance and Maintenance

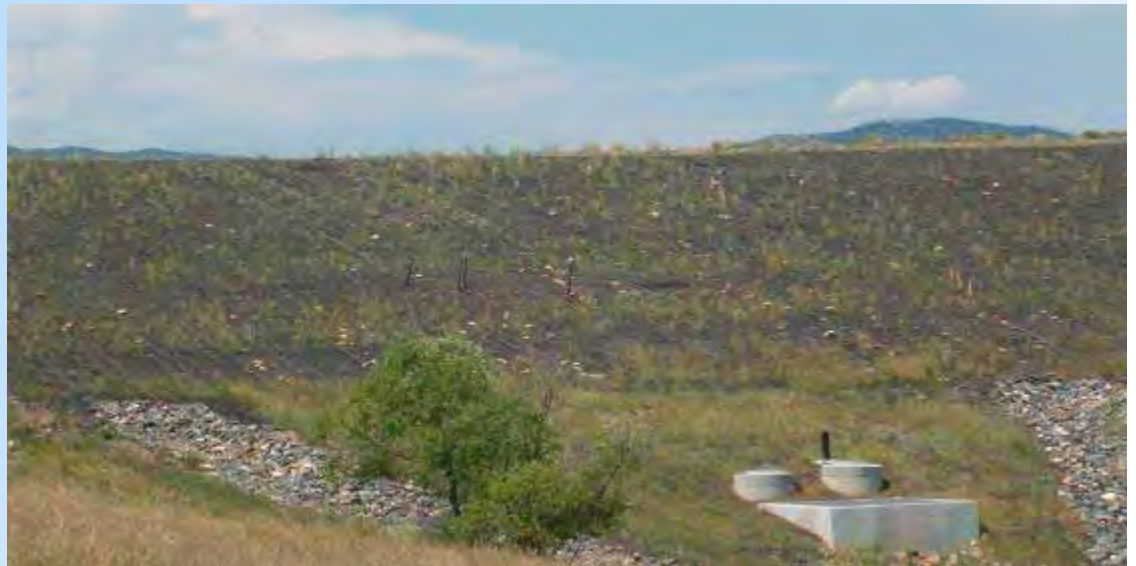
- Quarterly inspections performed for the 1st and 2nd quarters
- Monthly inspections performed for the 3rd and 4th quarters
- Vegetative cover inspected monthly from July through end of growing season
- Followed prescribed checklist in Monitoring and Maintenance Plan (May 2006)
- **No significant concerns**

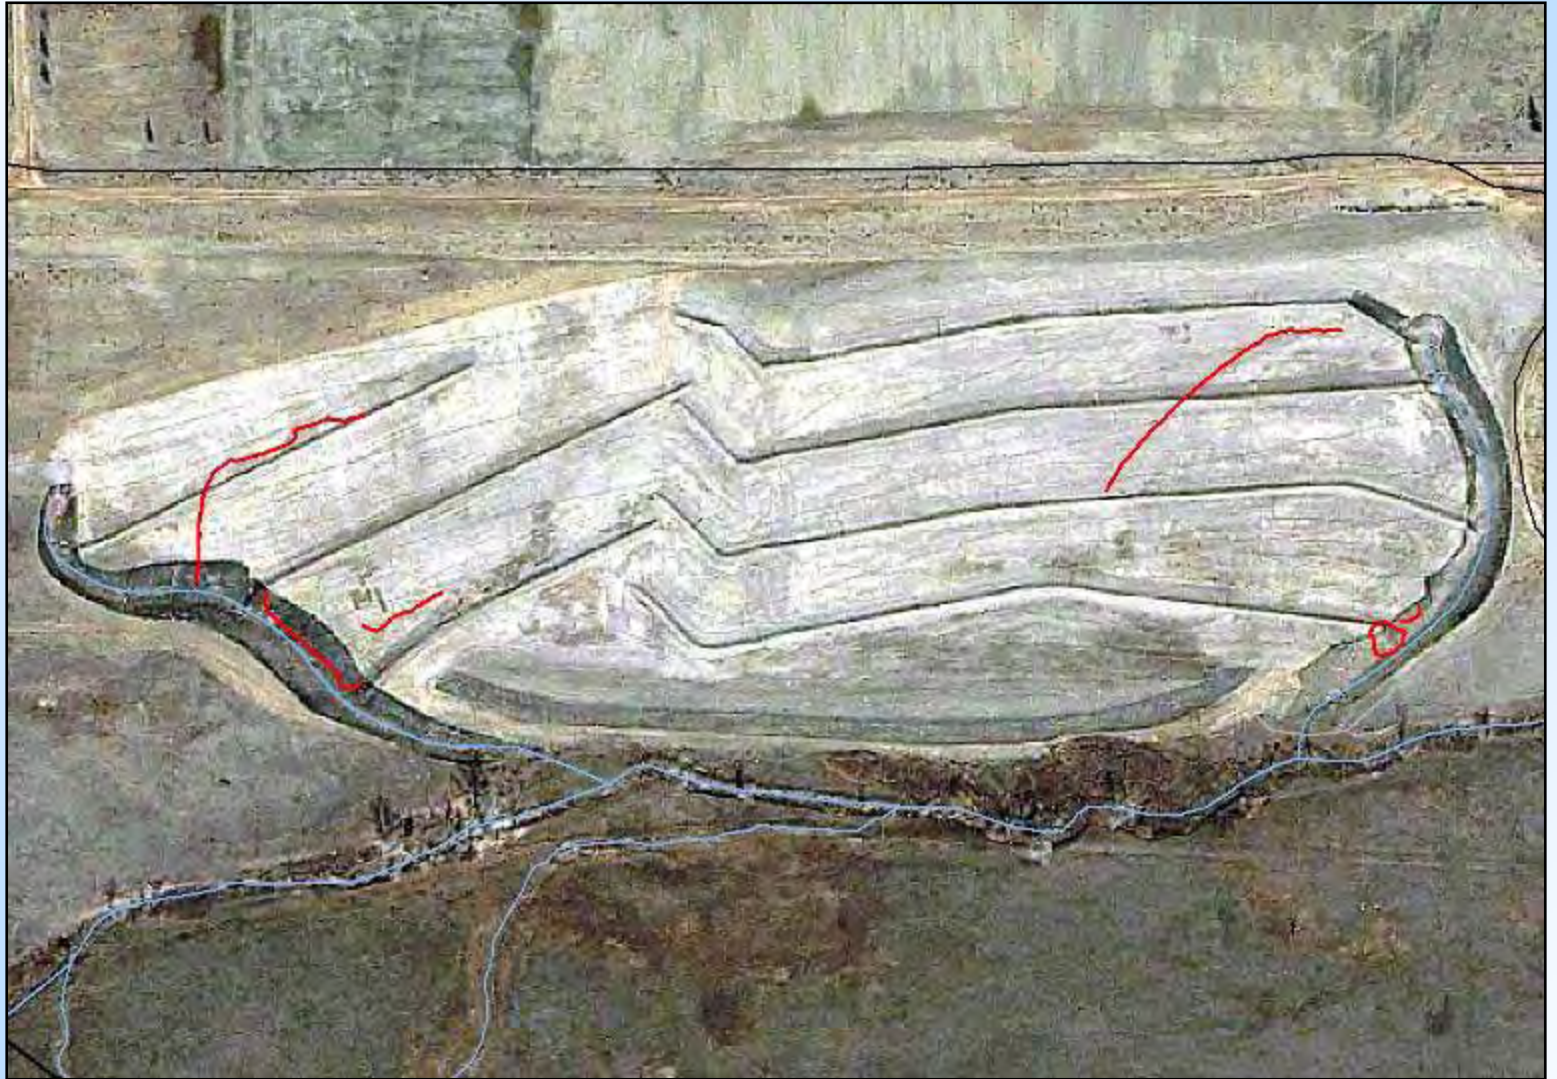
Original Landfill Slumps

- **Original Landfill Seeps and Slumps**
 - Seep #7
 - Investigation of “burrito drain”
 - Seep #4
 - Shallow trench dug to the West Perimeter Ditch
 - West Perimeter Ditch slump

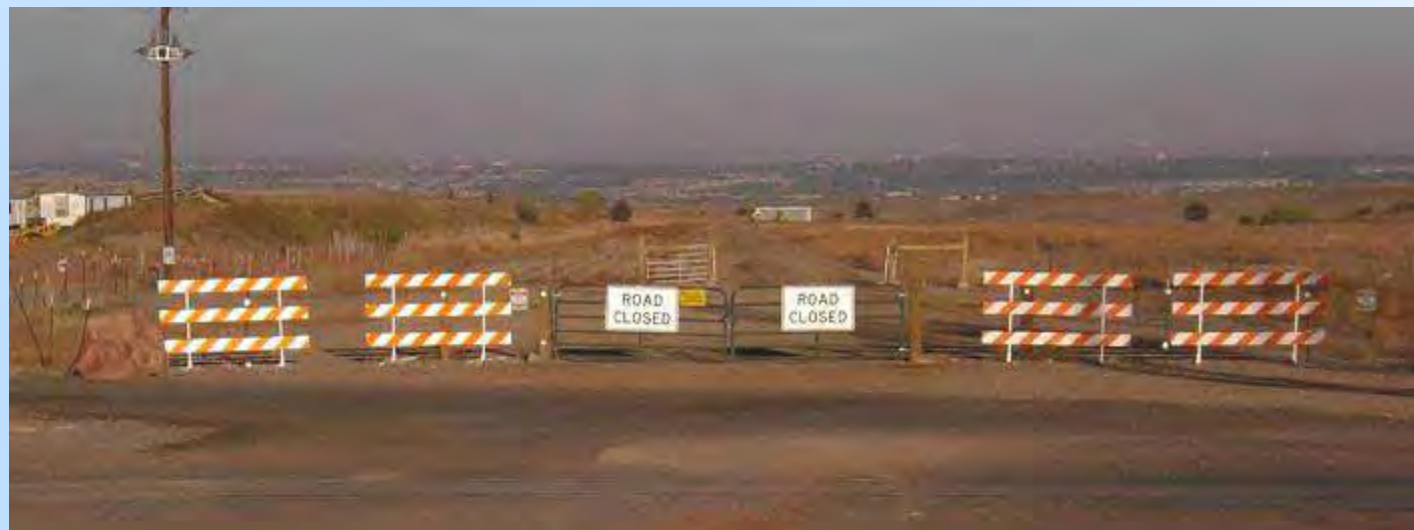
- **Access/Security**
 - West Access gate
 - Signage has reduced vehicle damage
 - East Property Boundary
 - Frequent maintenance necessary
 - Surveillance Subcontract

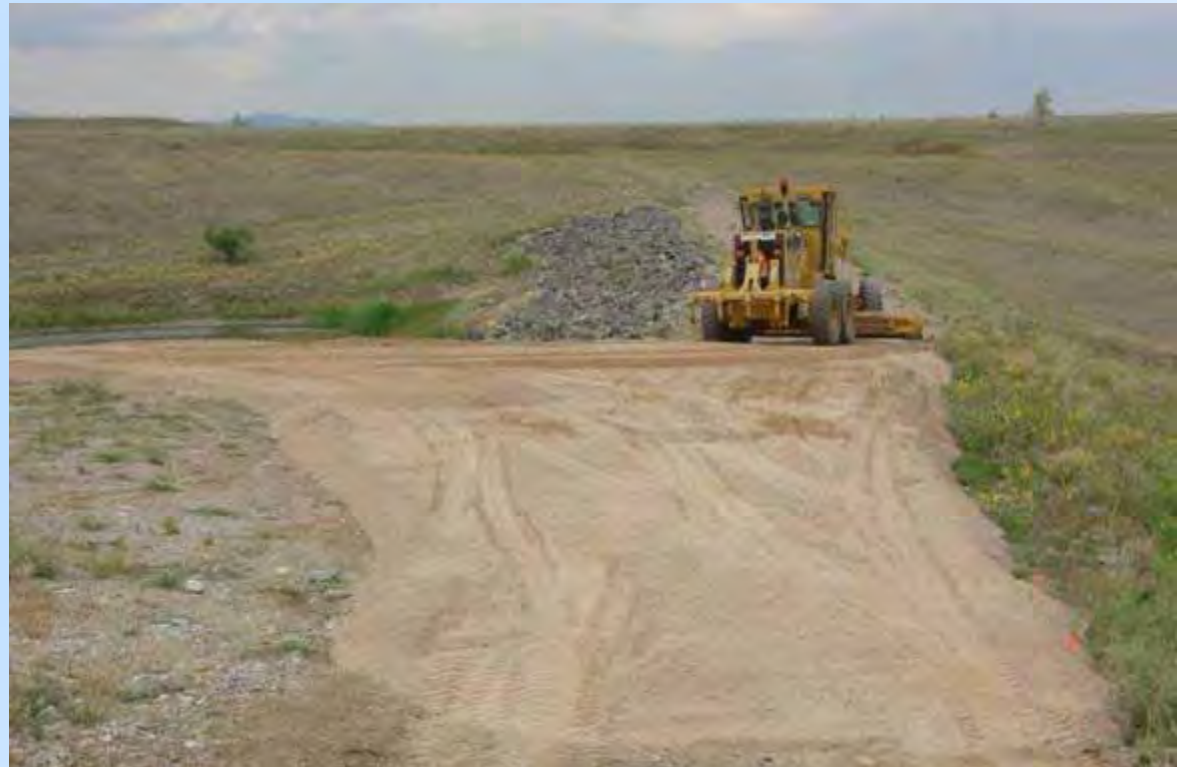
- **Site Road Upgrades**

- August & September
- Allow better all-weather access for surveillance and maintenance work
